PRODUCT SERVICE BULLETIN

FIX AS FAIL: L-Series; Rear Rims Cracking on L47

Product Line: L-Series

Model: L47

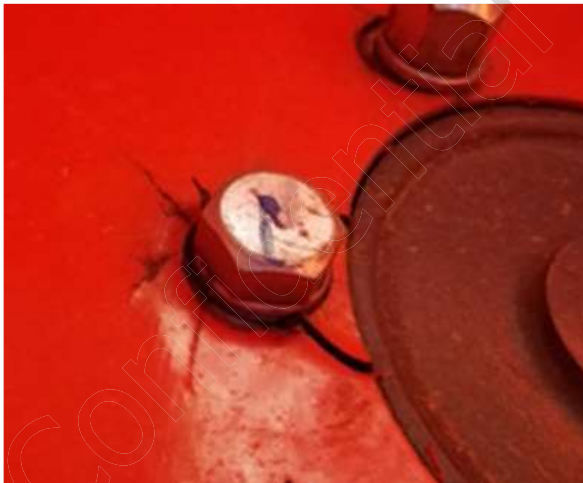
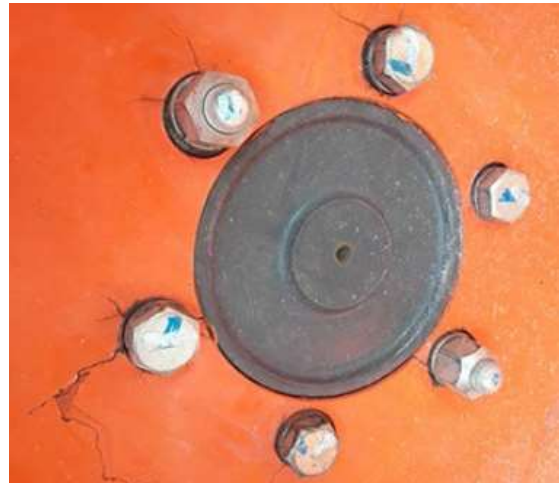
There is a possibility that cracks may occur around the mounting holes on the rear wheel; this only occurs when 15-19.5 tires are installed. It was determined that repeated load applied to the rear wheels, causes the bolts and nuts to loosen in the mounting holes and cause fatigue fracture.

If this failure occurs while 15-19.5 tires are installed, replace only the failed wheel/wheels and install new studs, nuts, and improved spring washers on both the left and the right sides per procedure on [page 3](#).
